# □ A guide to maintaining the IP8512 - Mini Whirl

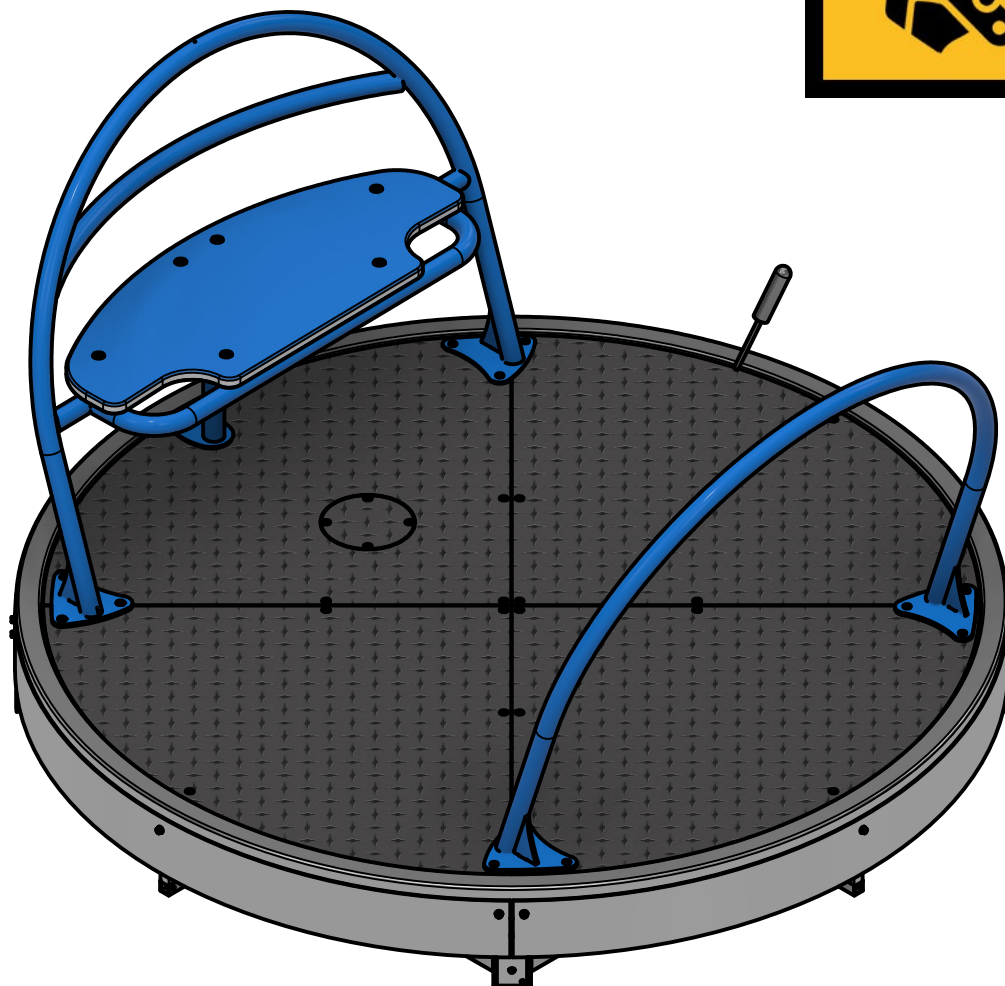
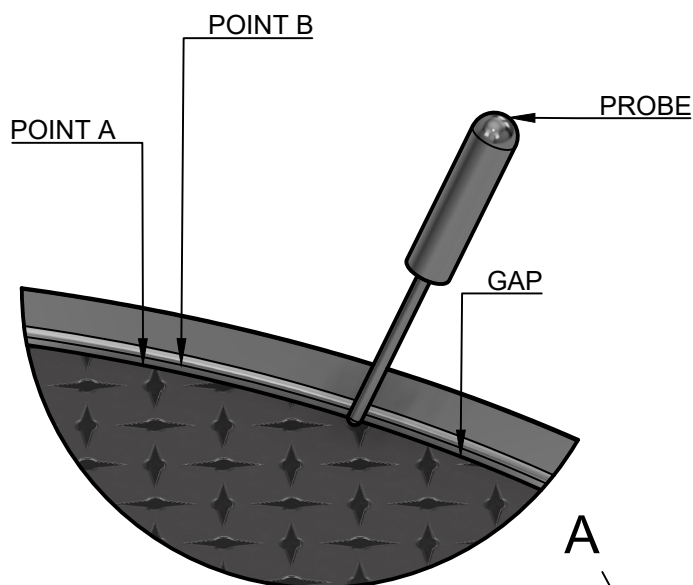
Upon inspection, it is vital the following checks are carried out:

- Ensure the rotation of the wheelspin runs smoothly.
- Check all fixings are secured tightly.
- Slowly rotate the unit and using the probe, ensure the gap between **Point A & Point B** does not exceed 8mm anywhere along the gap.

Only if required, adjustments can be carried out by loosening off the fixings on the Tread Plates and adjusting the positioning of the Tread Plates where necessary. This will help reduce any gaps along the Outer Gap that exceed 8mm.

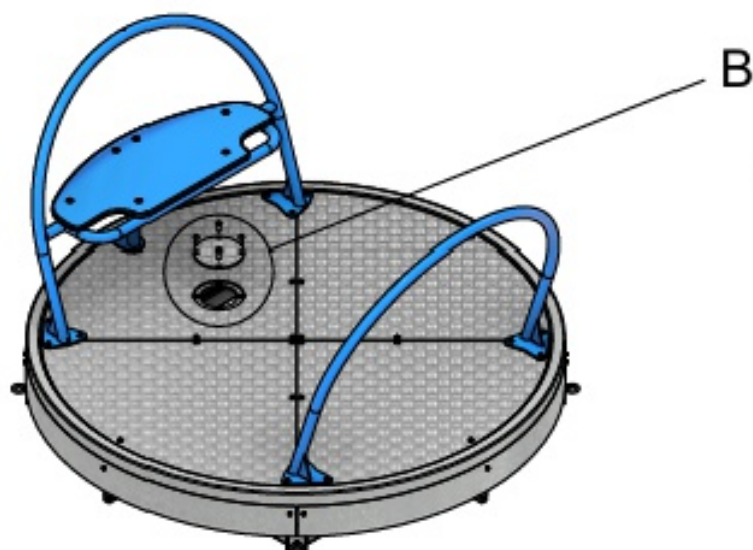
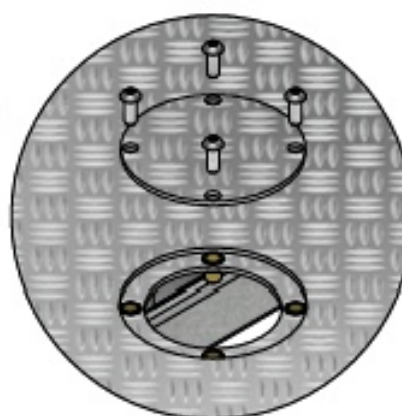
**02**

REMOVE (x4) 3/8-16"x1" TORX  
BUTTON HEAD SCREWS

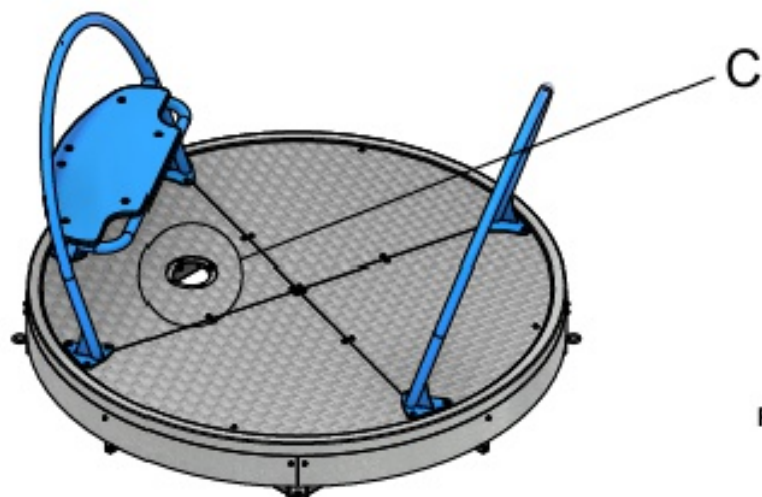
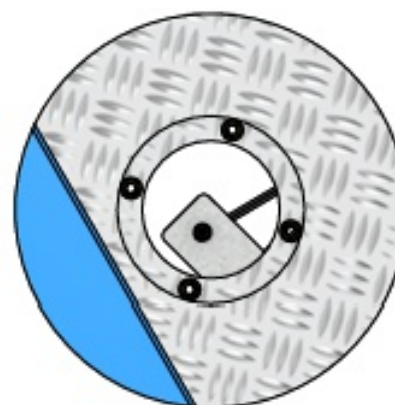
**03**

ROTATE UNIT UNTIL OPEN HATCH  
LINES UP WITH GREASE NIPPLE

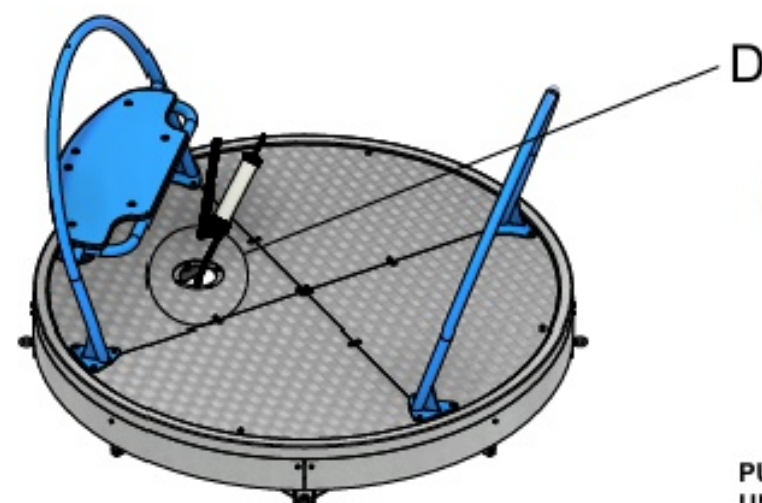
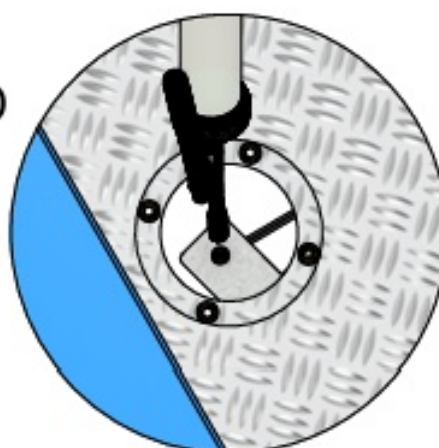
**04**

PUMP GREASE WHILE ROTATING THE  
UNIT AT LEAST 4 TIMES AT A STEADY  
PACE
